Chandra Flight Note

FLIGHT NOTE NO.	#572
SUBJECT	DEA Shutdown Anomaly Closeout
DATE	3/15/2016
AUTHOR	R. Edgar, G. Germain, K. Gage

Date: February 8, 2016
From: Richard J. Edgar and Gregg Germain
To: Chandra Operations Team
Subject: ACIS DEA-A Off anomaly, Sept 15, 2005
Cc: MSFC Project Science, CXC Director's Office
File: DEA-A-off_memo.tex
Version: 1.4

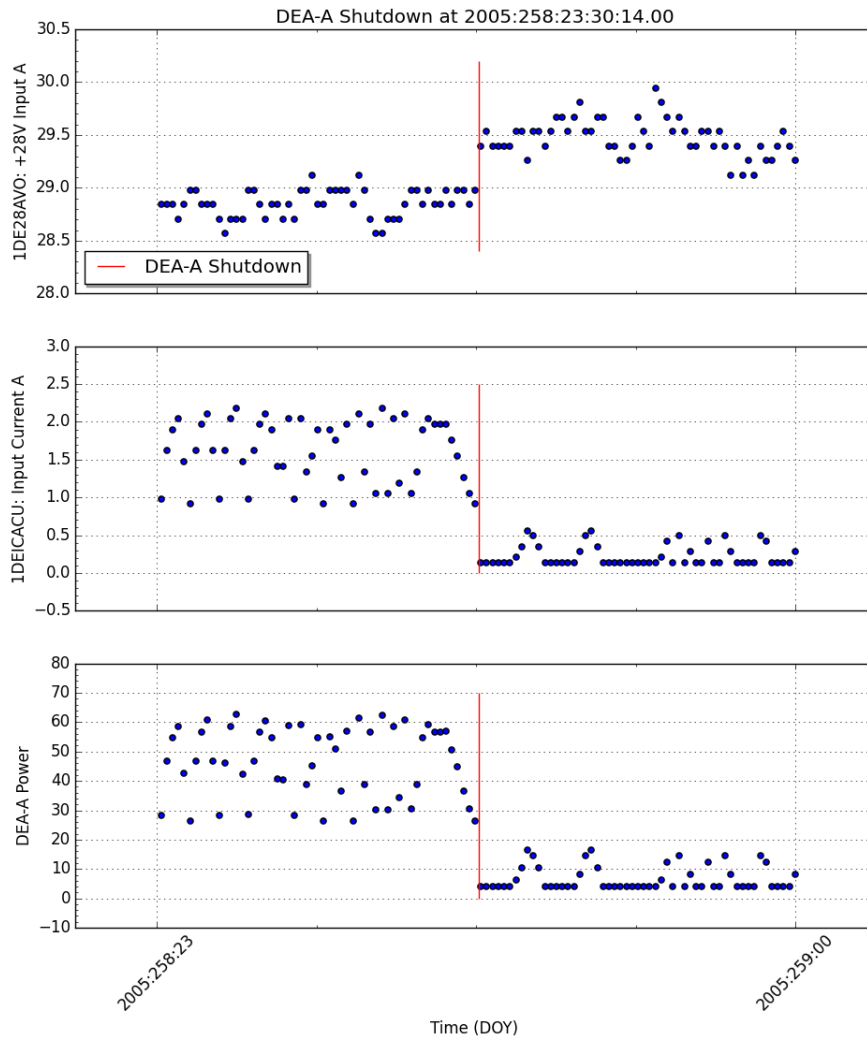
1DE28AVO, the 28-volt input power voltage for the DEA power supply, showed a small uptick, as expected if the load suddenly drops to near zero. Note the variability in the input current 1DEICACU, and hence the power derived from it, is an expected feature of the current monitor and is unrelated to the anomaly.

Figure 1: DEA side A 28v input voltage and current vs. time.

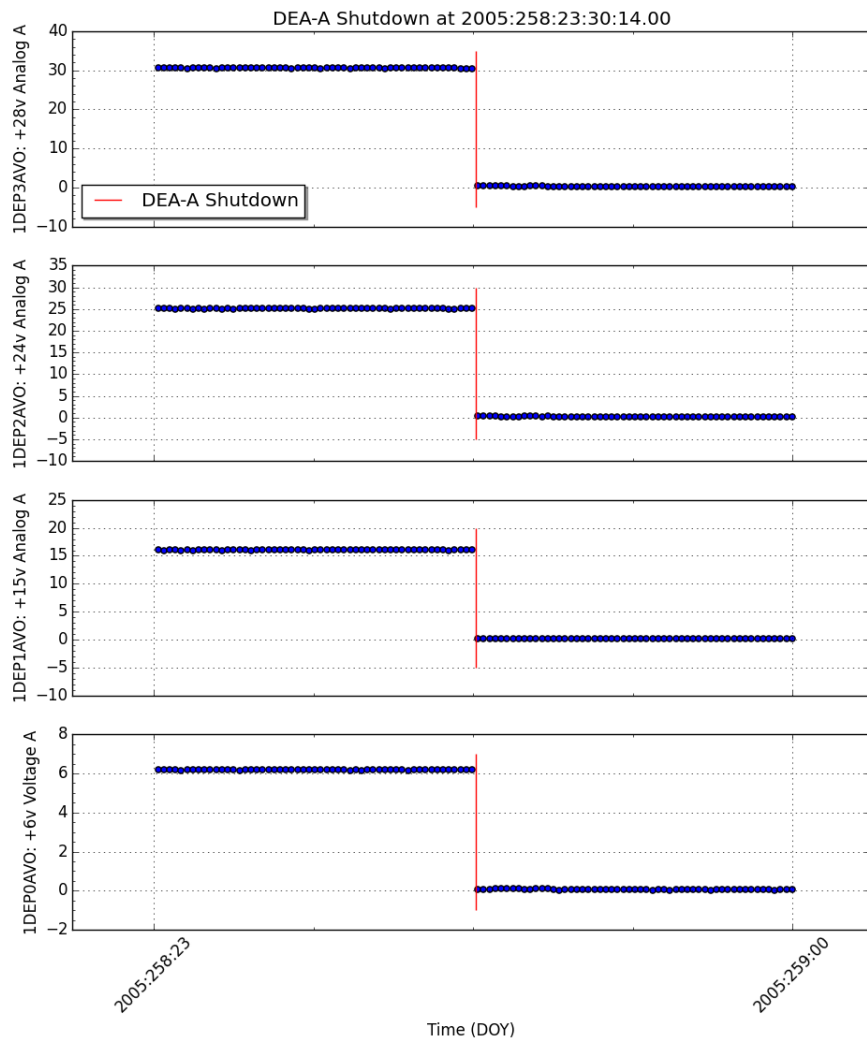
The data are consistent with all power system changes happening at once, and the apparent dispersion in times results from the precise location of the telemetry items in the major frame. The following telemetry items changed: 1DEPSA, the DEA Power Supply on/off indicator, from ON to OFF. Note 1DEPSAX remained with status ENABLED. The DEA input current, 1DEICACU, changed from 0.91 to 0.14 amps. The A-side analog voltages changed as follows: 1DEP3AVO, the +28V supply, from +30.5 to +0.45 volts; 1DEP2AVO, the +24V supply, from 25.2 to 0.36 volts; 1DEP1AVO, the +15V supply, from 16.1 to 0.15 volts; 1DEN0AVO, the -6V supply, from -6.35 to -0.15 volts; and 1DEN1AVO, the -15V supply, from -16.1 to 0.38 volts.

Figure 2: DEA side A positive analog voltages vs. time

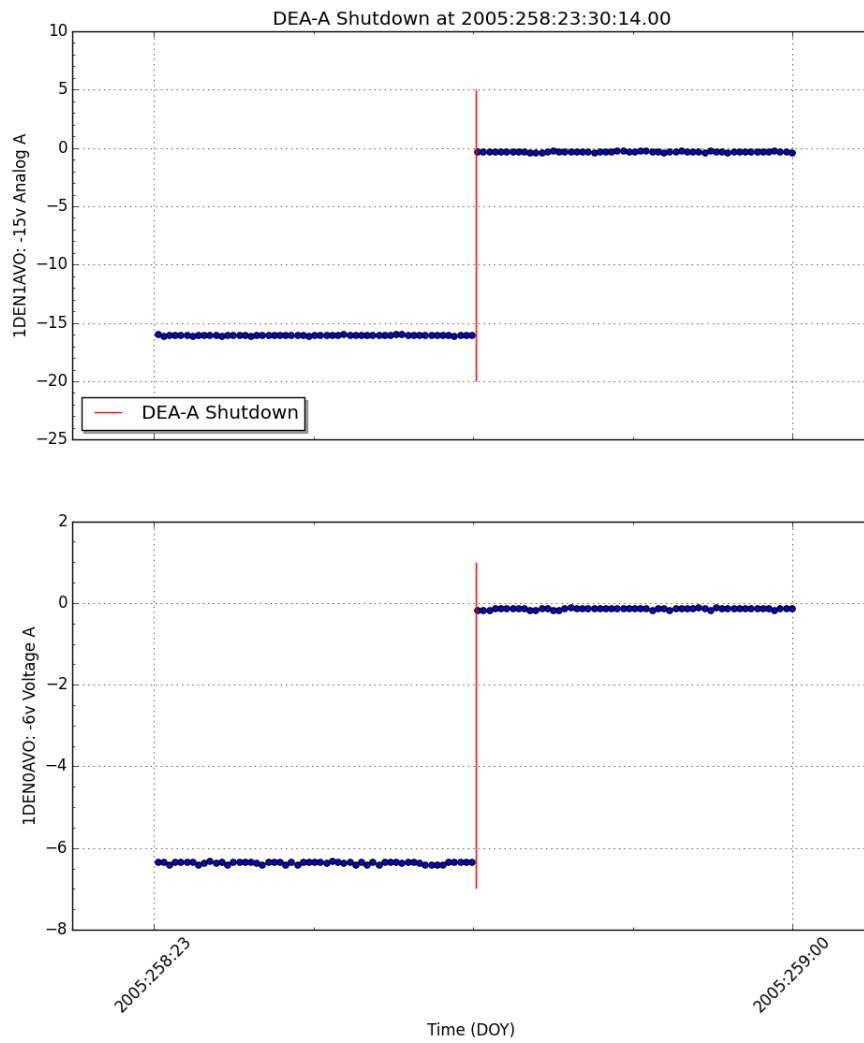
Figure 3: DEA side A negative analog voltages vs. time.

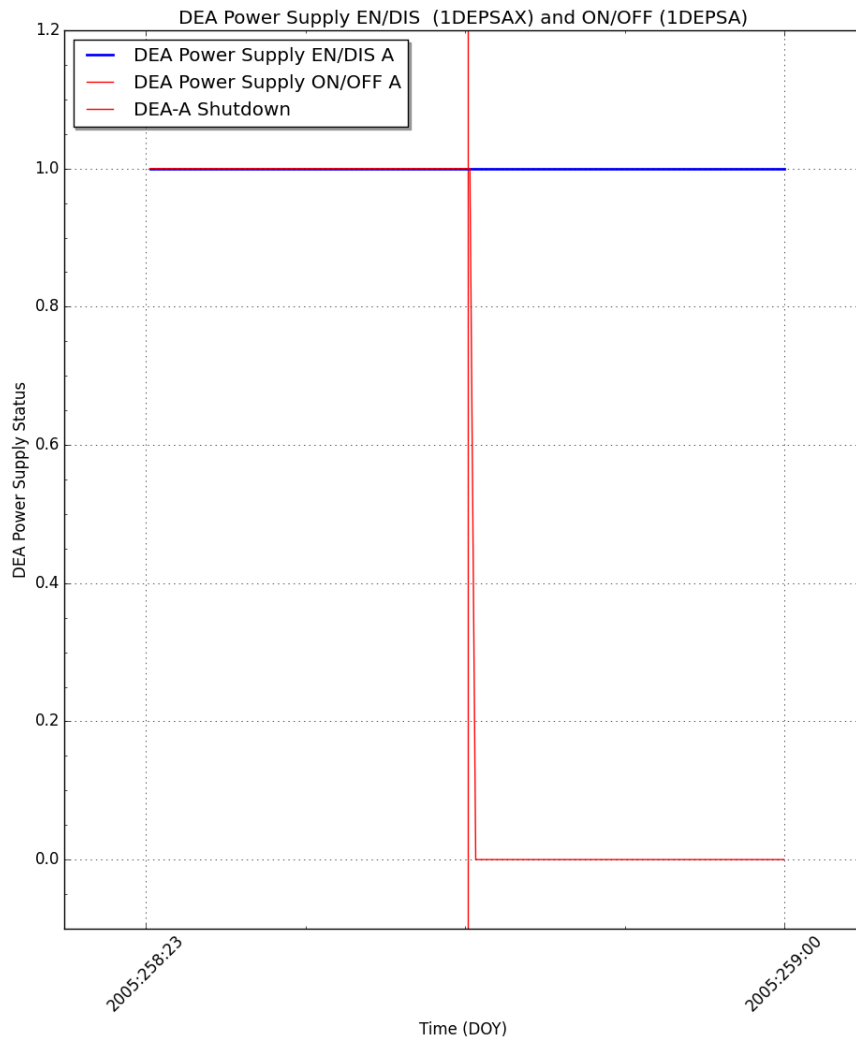
Figure 4: DEA side A power enable and on/off indicators. Note the power supply remained enabled.

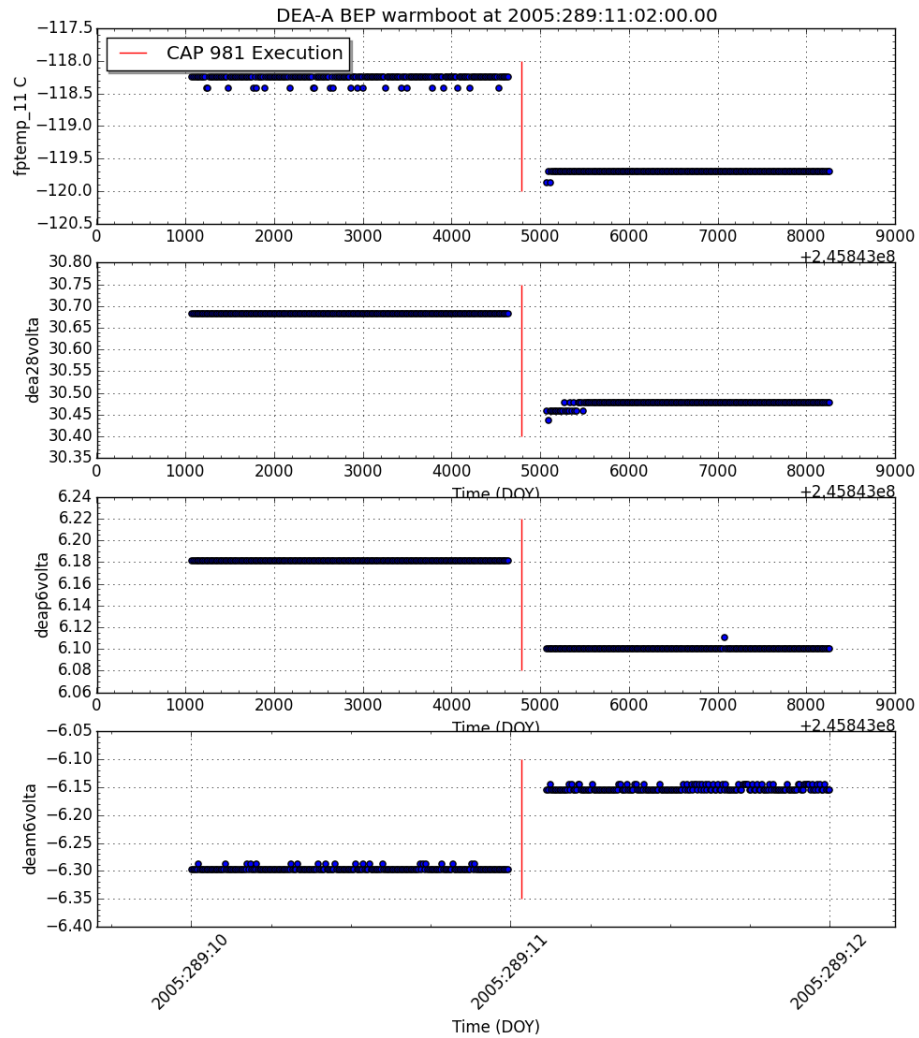
However, the A/D converter items reported on the ACIS PMON pages do show an immediate jump at the warm boot of the BEP. Most notable among those are the focal plane temperature (fptemp_11), and the DEA voltages (dea28volta, dea24volta, deam15volta, deap15volta, deam6volta, and deap6volta). These are stored as pseudo-MSIDs in the ska engineering database. For nearly identical circumstances before the anomaly, before the warmboot, and after the warmboot (i.e. the same SI mode was executing in a similar thermal environment), the focal plane temperature, and the +24 and +6 volt power supplies

in particular, returned to their pre-anomaly values after the warmboot, while exhibiting different values between the anomaly recovery and the warmboot.

We plot a few of these items near the time of the warm boot in figure 5.

Figure 5: Selected A/D Converter data reported in the DEA housekeeping data, on the PMON page, around the time of CAP 981, rebooting the BEP. Note the perceptible jumps. These items returned to their pre-anomaly values after this CAP.

It is recommended that the ACIS team monitor these values carefully following this kind of an anomaly recovery, to be sure the A/D converters are operating in their calibrated, high-resolution mode.

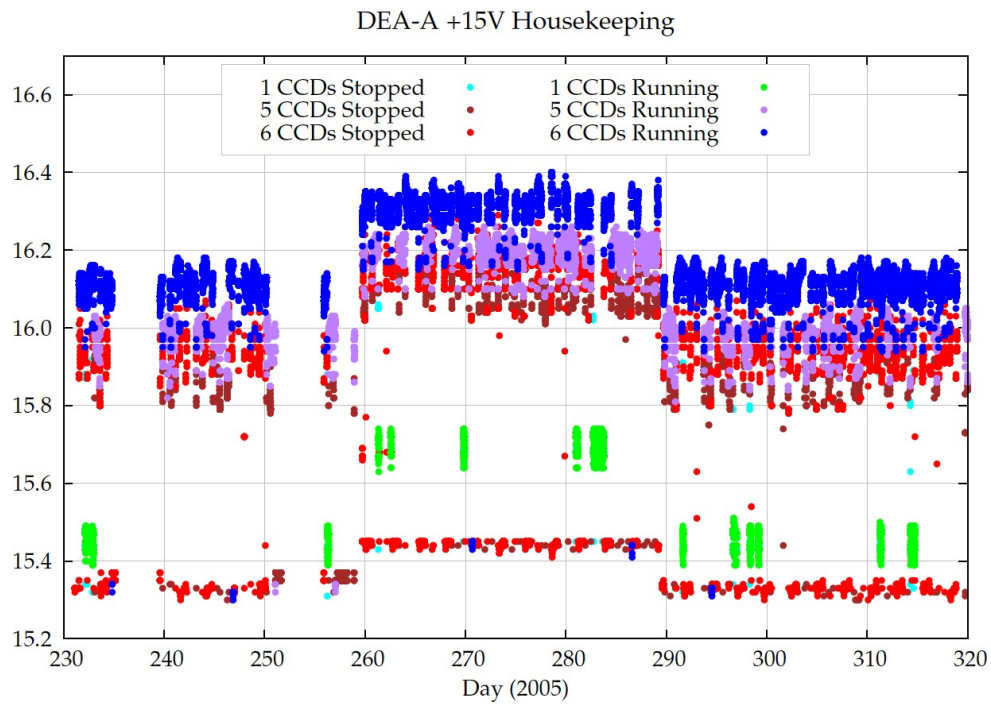
This effect is even more clear in figure 6, kindly supplied by Peter Ford of MIT. Here the +15v analog power supply, as read out through the A/D converters in question, is plotted vs time for the period covering from 30 days prior to the DEA-A power anomaly, through 30 days following the BEP reboot. Points are color coded by the number of video boards powered, and whether they were clocking (as revealed by the 1STAT1ST status bit). This plot also gives an idea of the integration time required to be sure to detect an uncalibrated A/D converter.

Figure 6: The DEA +15v analog voltage supply, from 30 days prior to the anomaly, through 30 days after the BEP reboot. Colors encode the number of video boards powered, and whether they were clocking (as seen by the 1STAT1ST status bit). Note the jumps at the time of the anomaly and at the BEP reboot.
