Chandra Flight Note

FLIGHT NOTE NO.	#553
SUBJECT	Day 2014/185-187 Mission Load Segment Uplink Error
DATE	09/07/2014
AUTHOR	Frank Schackart, Paul Viens

This flight note describes the Mission Load Segment Uplink Error of day 2014:185 and recommends closure.

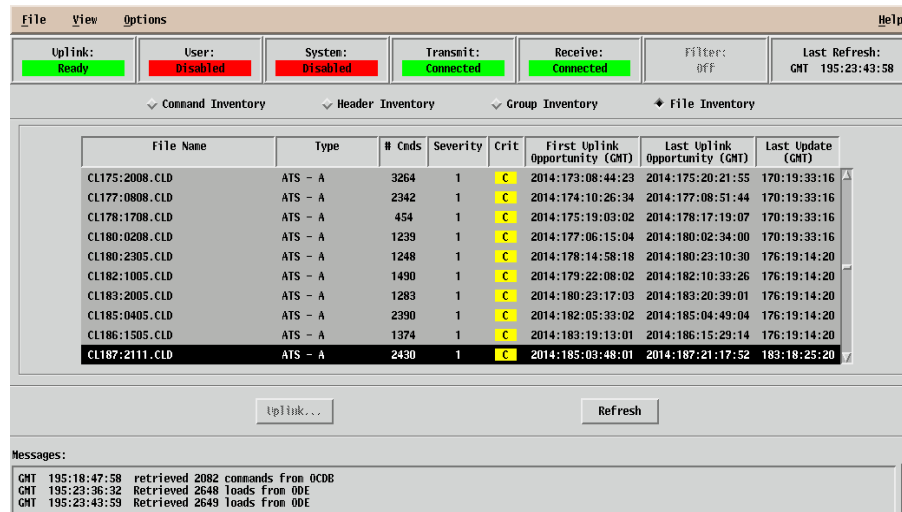
Although the OC/CC did compare the First Uplink Opportunity Time (seen on the Command Operations window) with the Load After time found in the hardcopy version of the JUL0714B load package, (which matched), neither checked the actual GMT time to ensure it was after the time specified on both the EHS Command Operations windows and the hardcopy information contained in the load package prior to uplinking CL187:2111 to SCS 128.

The screenshot images below show the First Uplink Opportunity Time as seen from the Command Operations window.

- e. An enhancement request for the ONLS to “check load before/after times before load uplinks” was submitted. The planned implementation will alert the controllers if they attempt to uplink an ATS load prior to its First Uplink Opportunity Time. The controller will have the option to override the warning if necessary, but the default response will be to cancel the load uplink. There will be no change for RTS loads, PRT loads or FSW patch loads. The enhancement is slated to be included in ONLS 4.1.
