# UPDATE ON HRC AND LETG ANOMALIES

D. PATNAUDE - 11/8/2021

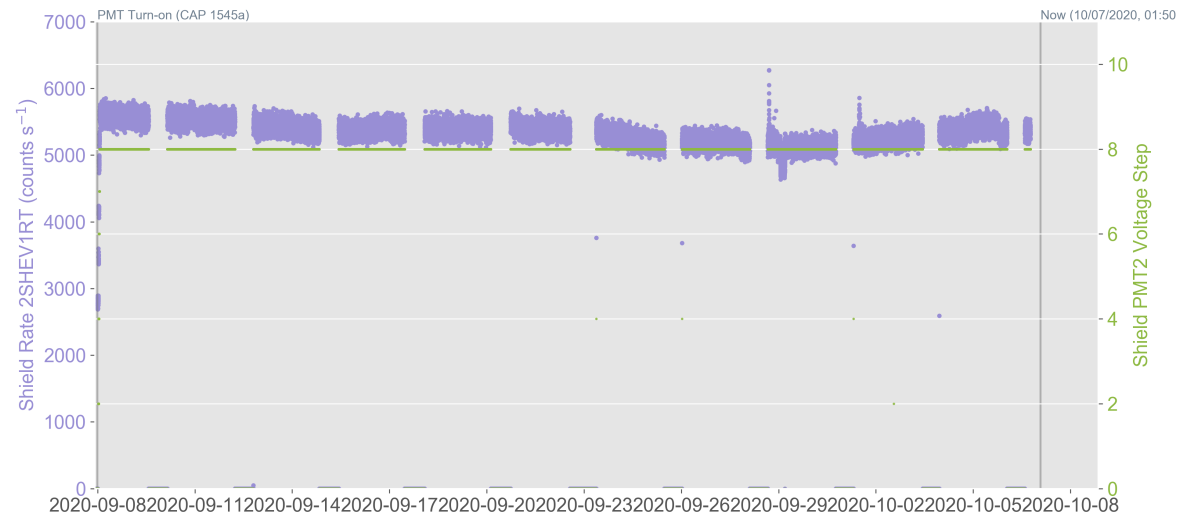
## HRC-I PMT#2 turn on:

- After remaining in standby mode for ~ 1 week, HRC PMT#2 was manually ramped up during a real time comm
- PMT rates were nominal and there has been no indication of issues while running on the B-side power supplies

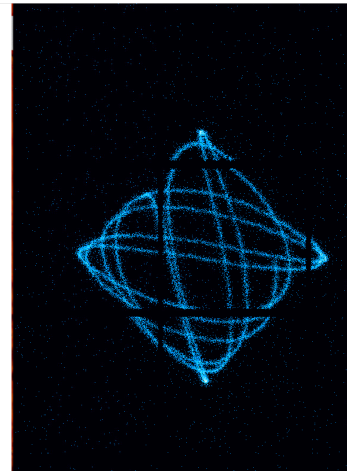
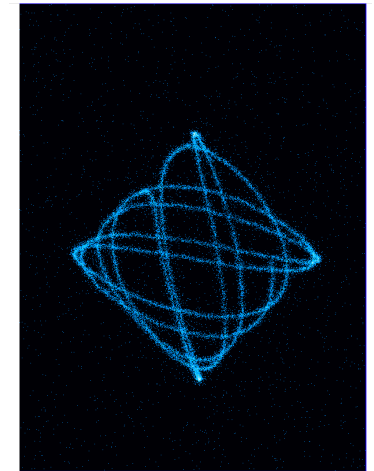
22772 - March 2020

**- we find no evidence for errors in the onboard processing of event positions at the HRC aimpoint -**

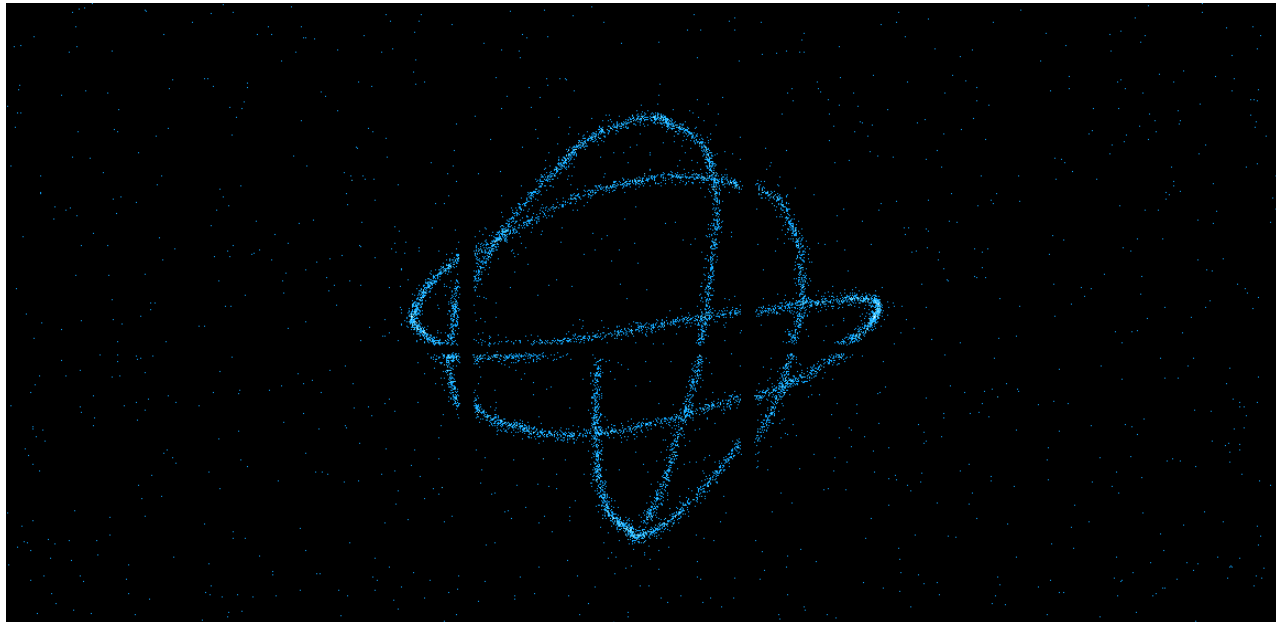
Comparison of AR Lac pre- and post-degap correction reveals no artifacts in dithered image. AR Lac observation only sampled signal processing at the detector aimpoint, and an observation which covers a larger fraction of the detector area is recommended

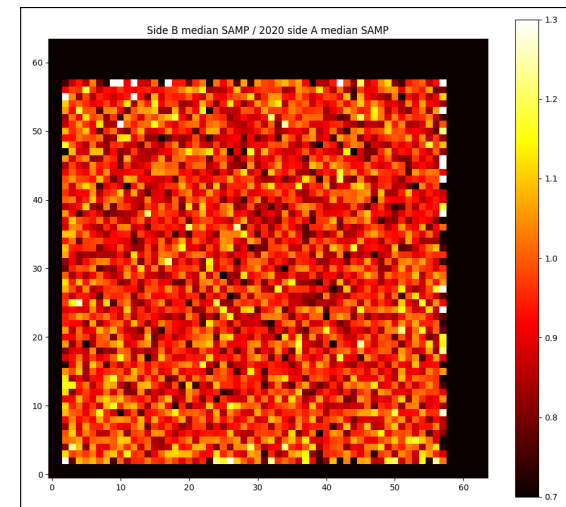
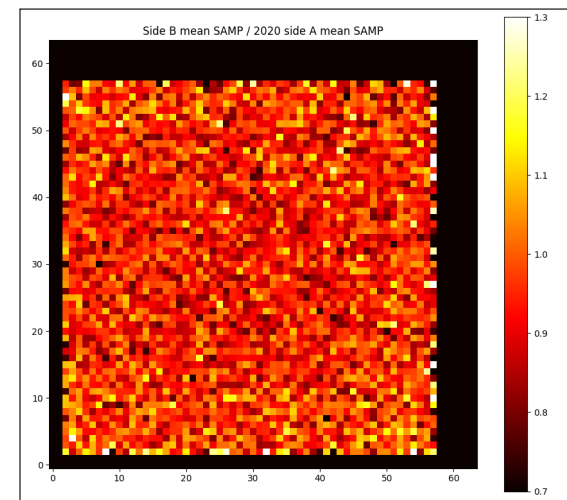
- looking at the pulse height amplitude, which samples the entire detector response for an event
- looking at the “SAMP,” which uses the sum of the 6 U and V amplifier signals, weighted by “amp\_sf,” which is a dynamic gain adjustment determined by event processing logic. Since SAMP only uses the event signal from the 6 amplifiers, it is a better representation of the detector gain
- excluding AR Lac, the mean and median SAMPs for each coarse U and V position were compared to observations in March 2020, and Oct 2019
- On side A, between October 2019 and March 2020, the detector experienced a drop in both the mean and median SAMP  $\sim 5\%$
- comparison of side B observation to March 2020 observation on side A reveals a similar drop of  $\sim 5\%$

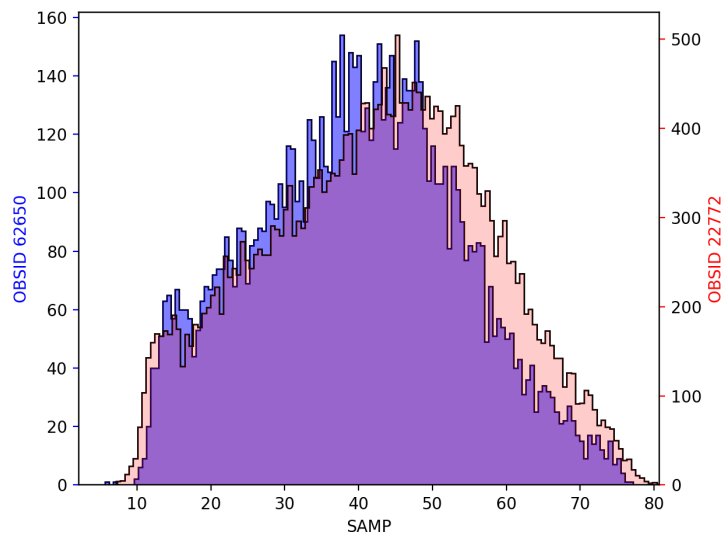
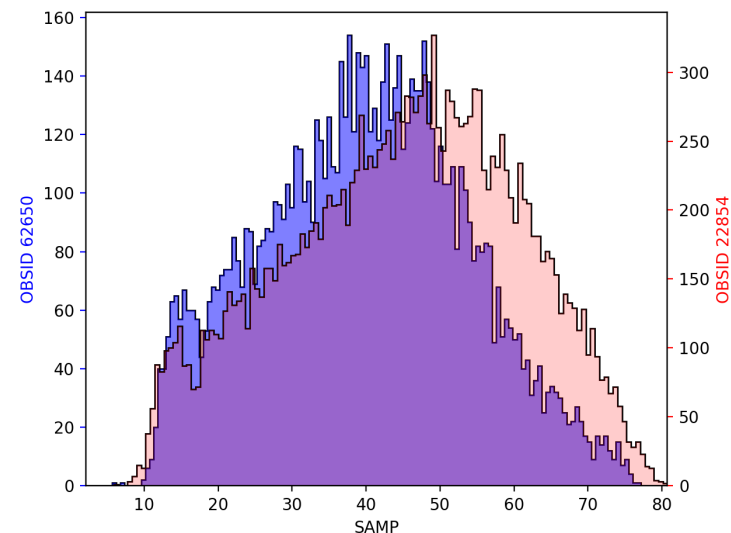
- between Oct 2019 and March 2020, the median SAMP dropped by ~ 6%, while the mean SAMP dropped by ~ 6%
- between the A-side and B-side observations, the median SAMP dropped by ~ 7%, while the mean SAMP dropped by ~ 6%.
- \*both comparisons look at amp\_sf = 1 only

OBSID 62650 SAMP histogram for AR Lac, compared to OBSID 22772 (Mar, 2020; left panel) and OBSID 22854 (Oct 2020, right panel). For both plots, the left Y-axis corresponds to the blue histogram, while the right Y-axis corresponds to the red histogram.

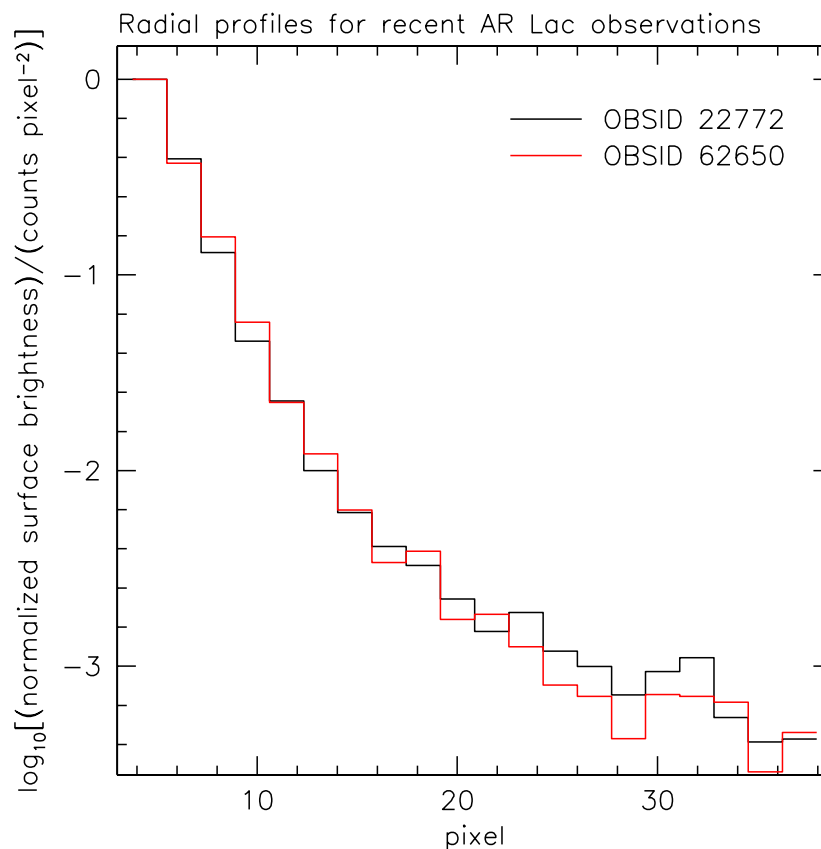
- We evaluated any changes in the PSF by looking for differences in the radial profiles of AR Lac from observations done in Mar 2020 and the recent checkout observation.
- The microchannel plates and cross grid charge detector are the same as were used on the A-side, so no changes in PSF are expected from those components
- If there is a drop in the gain due to differences between the A- and B-side preamps, then electronics noise could broaden the PSF.
- Changes in 50% and 85% encircled energy are consistent with recent trends

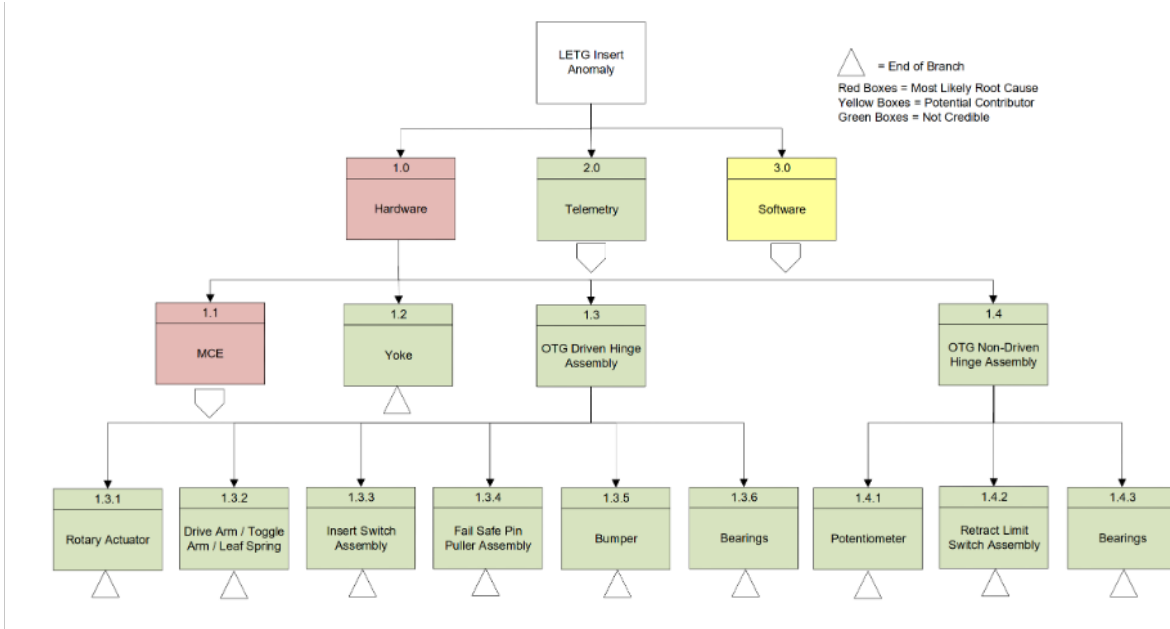
- Fault tree investigation completed
- Most likely root cause identified
- Temperature dependence in 58 Hz clock in MCE
- Contributing cause identified as OTG support K-constants in OBC FSW
- no other failures or contributing factors were identified

- Continue to limit OBA Forward Bulkhead and ACA temperatures as control for MCE temperatures
- No limit increases on OBA or ACA until MCE cleared for higher temperatures or a MCE specific model and guideline are in place
- Restore HETG to nominal operations - **complete**
  - Moves are safe
  - Speed variation does not change likelihood of move success
- Patch LETG move parameters to account for speed variation - **complete**
- Restore LETG to nominal operations - **complete**
- Add load review check of temperature adjusted OTG move angles - **complete**
- Investigate operation of MCE above temperatures demonstrated in flight - **complete**
