## ACIS HW Training

## Overview of ACIS HW

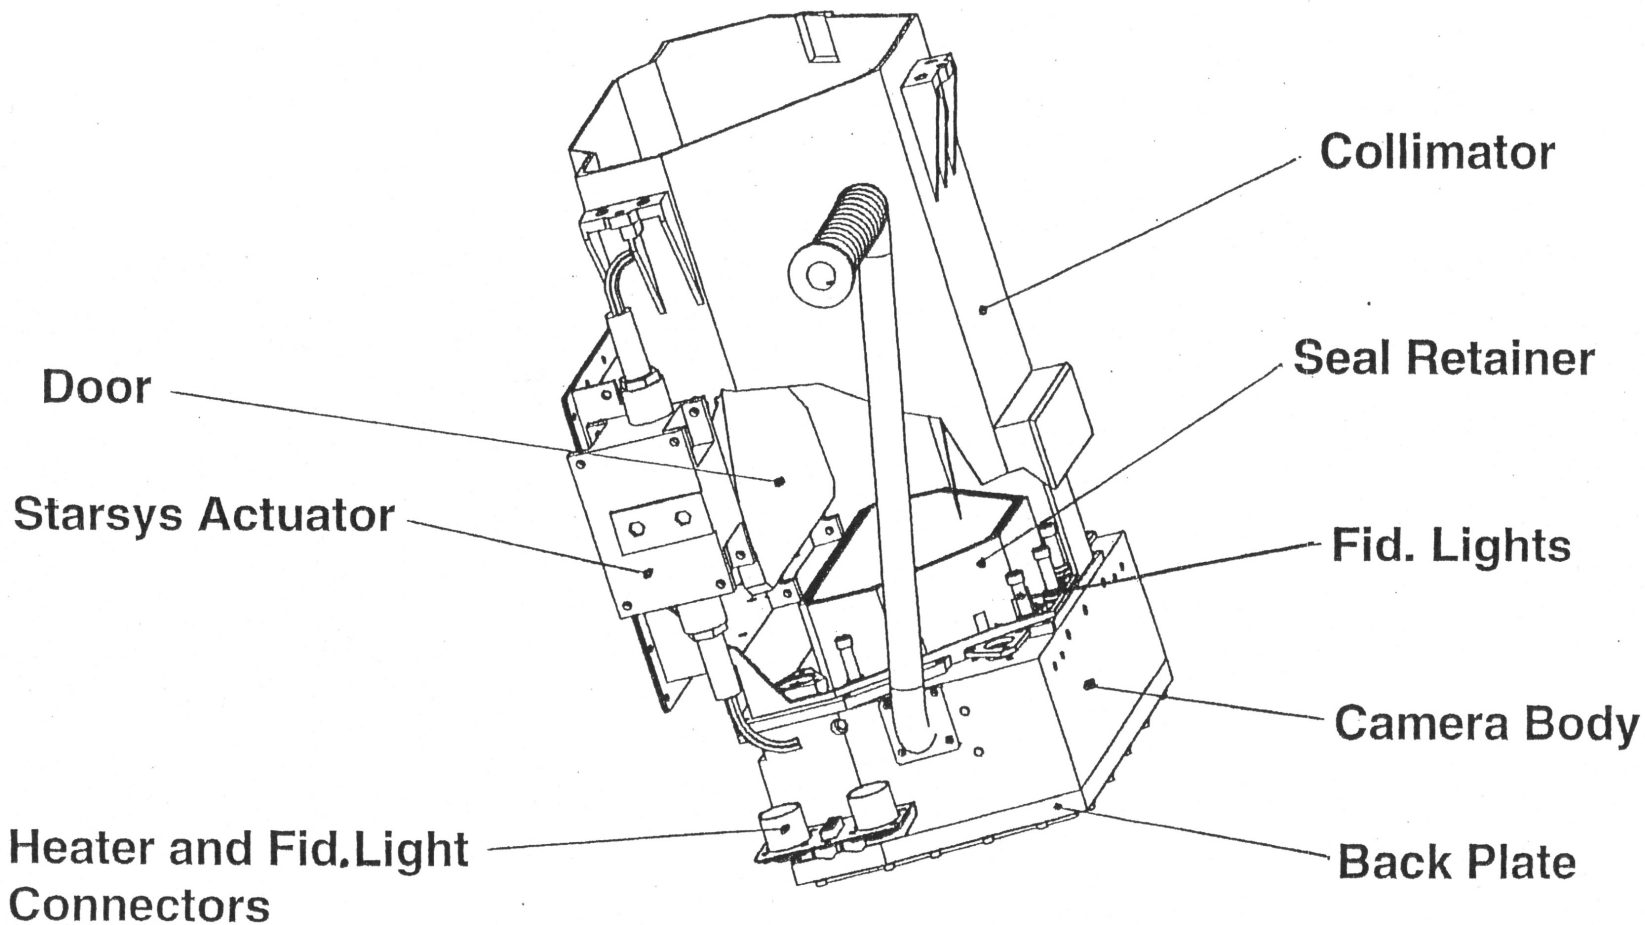
## ACIS Detector Housing

**DH, Detector Housing** - contains CCD focal plane (FP), optical blocking filter (OBF), proton shield, collimator [Lockheed-Martin and Lincoln Laboratories]

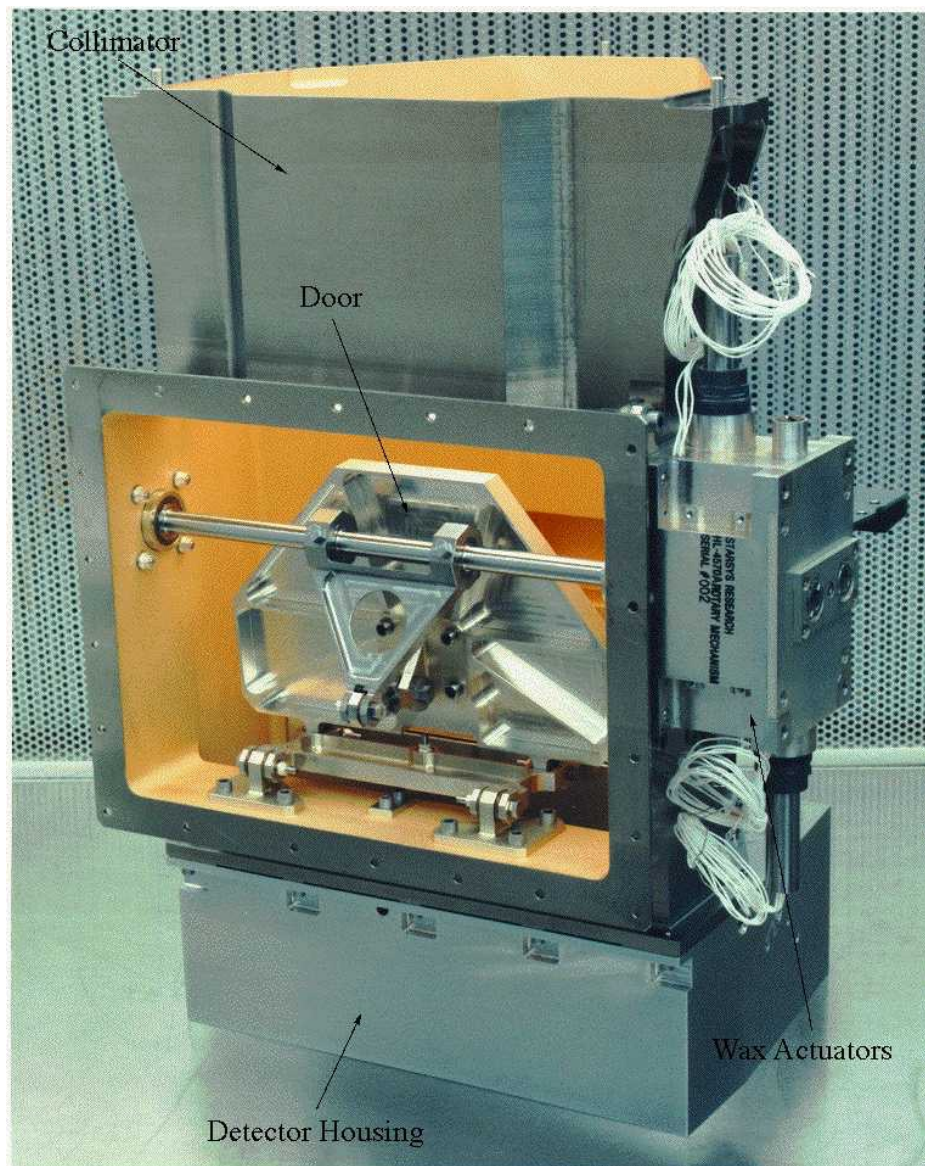
## ACIS Engineering Unit & Door Mechanism

Door opened on 8 August 1999  
Camera Body heated to  
1CBAT/1CBBT to +17.8/22.8  
FP heated to +31.6 C

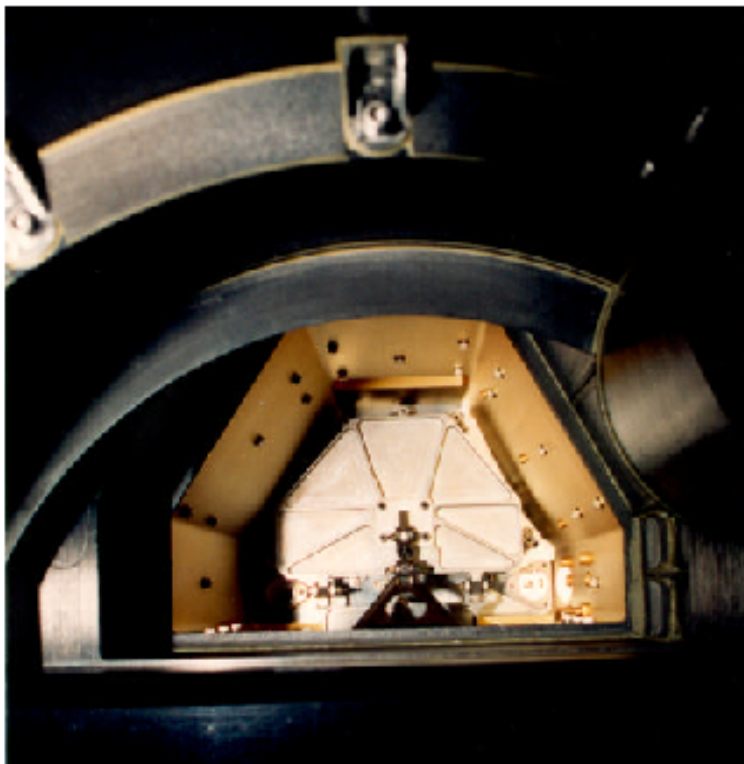
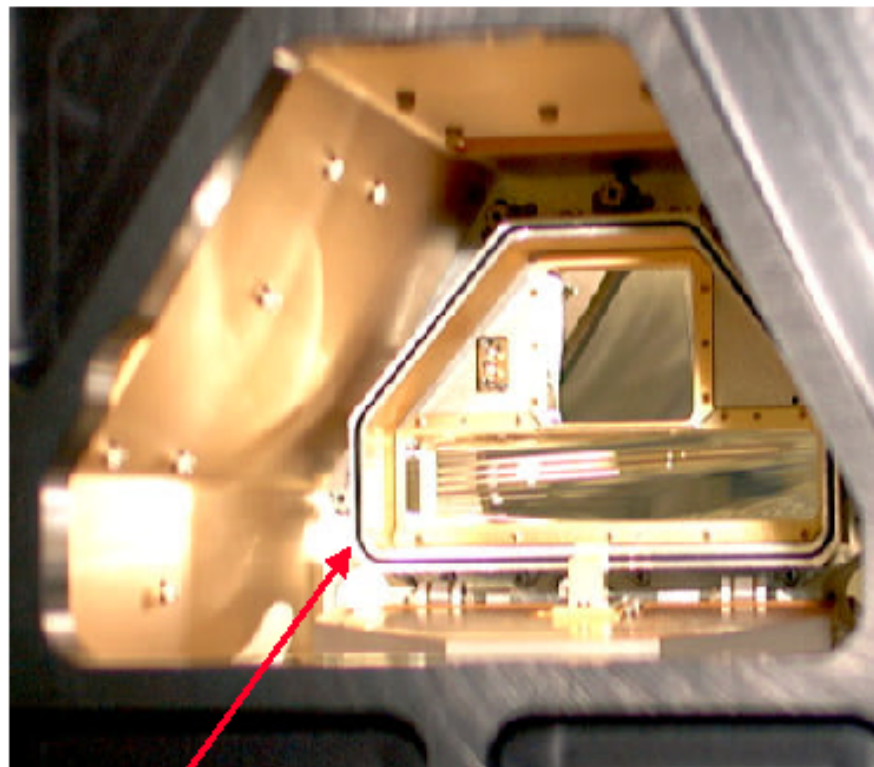
## X-Ray View of ACIS Door and Detector

Door Closed while Mounted to ISIM

Door Open at LMA

Viton O-ring

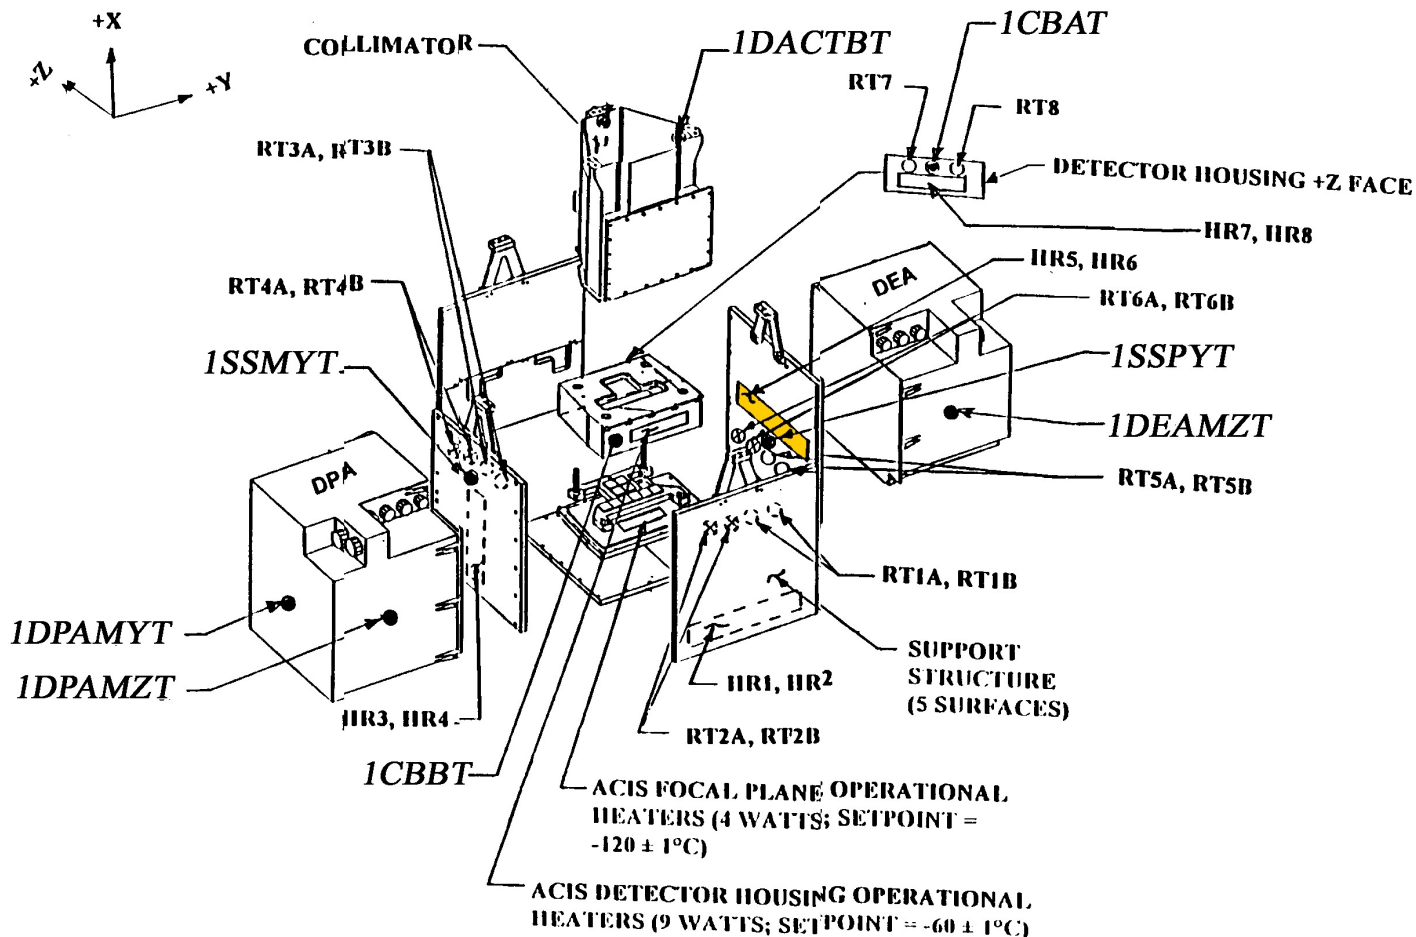
## ACIS SS & DETECTOR HOUSING TRIM & SURVIVAL HEATERS & TEMP. TELEMETRY

ACIS  
thermistors  
and  
heaters

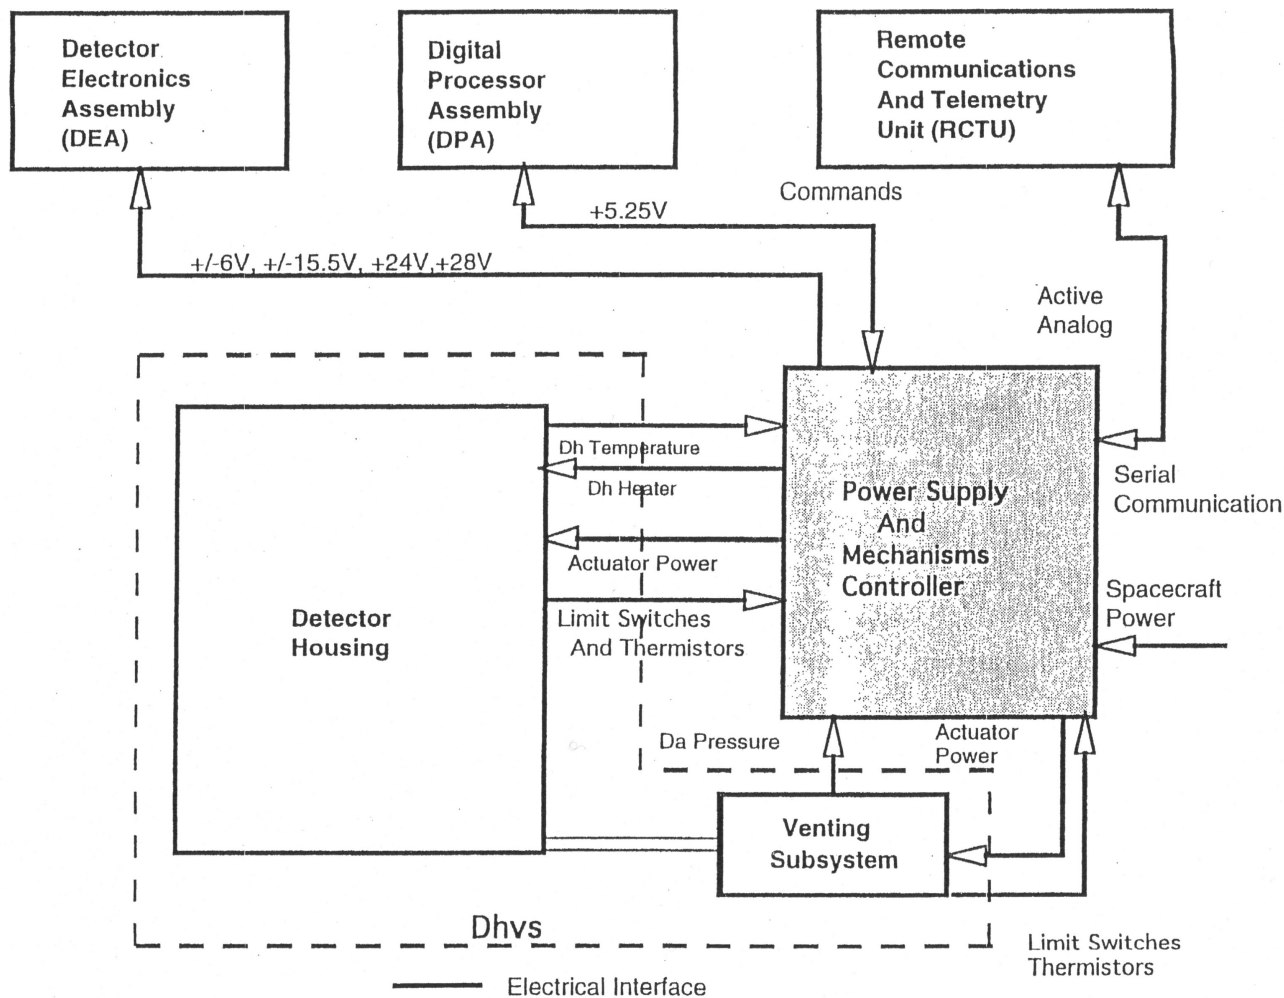
## ACIS PSMC Interfaces

PSMC is the connection to the spacecraft, both in terms of power and HW commands/telemetry

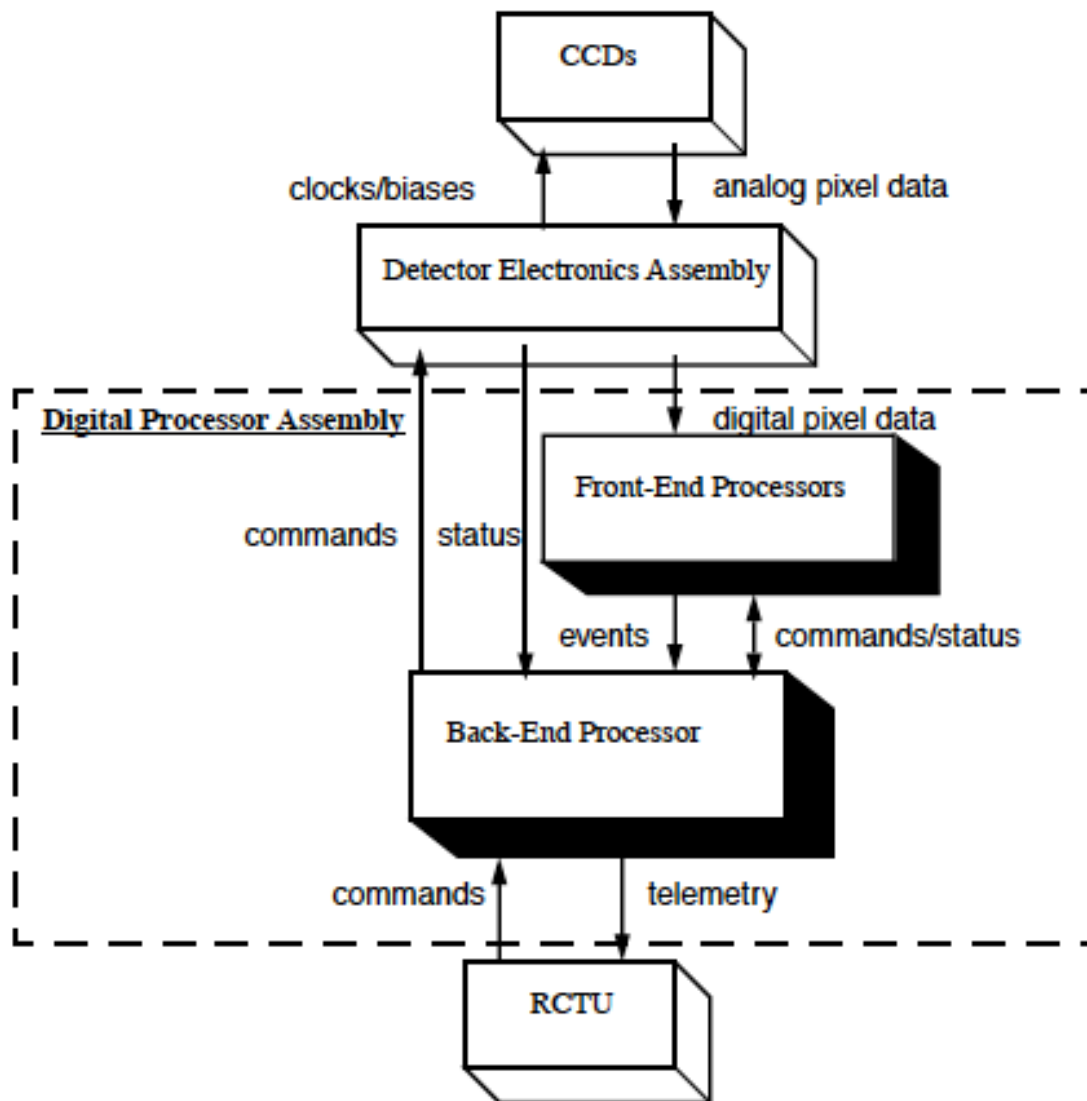
## ACIS DPA Interfaces

FIGURE 1. DPA Interface Overview

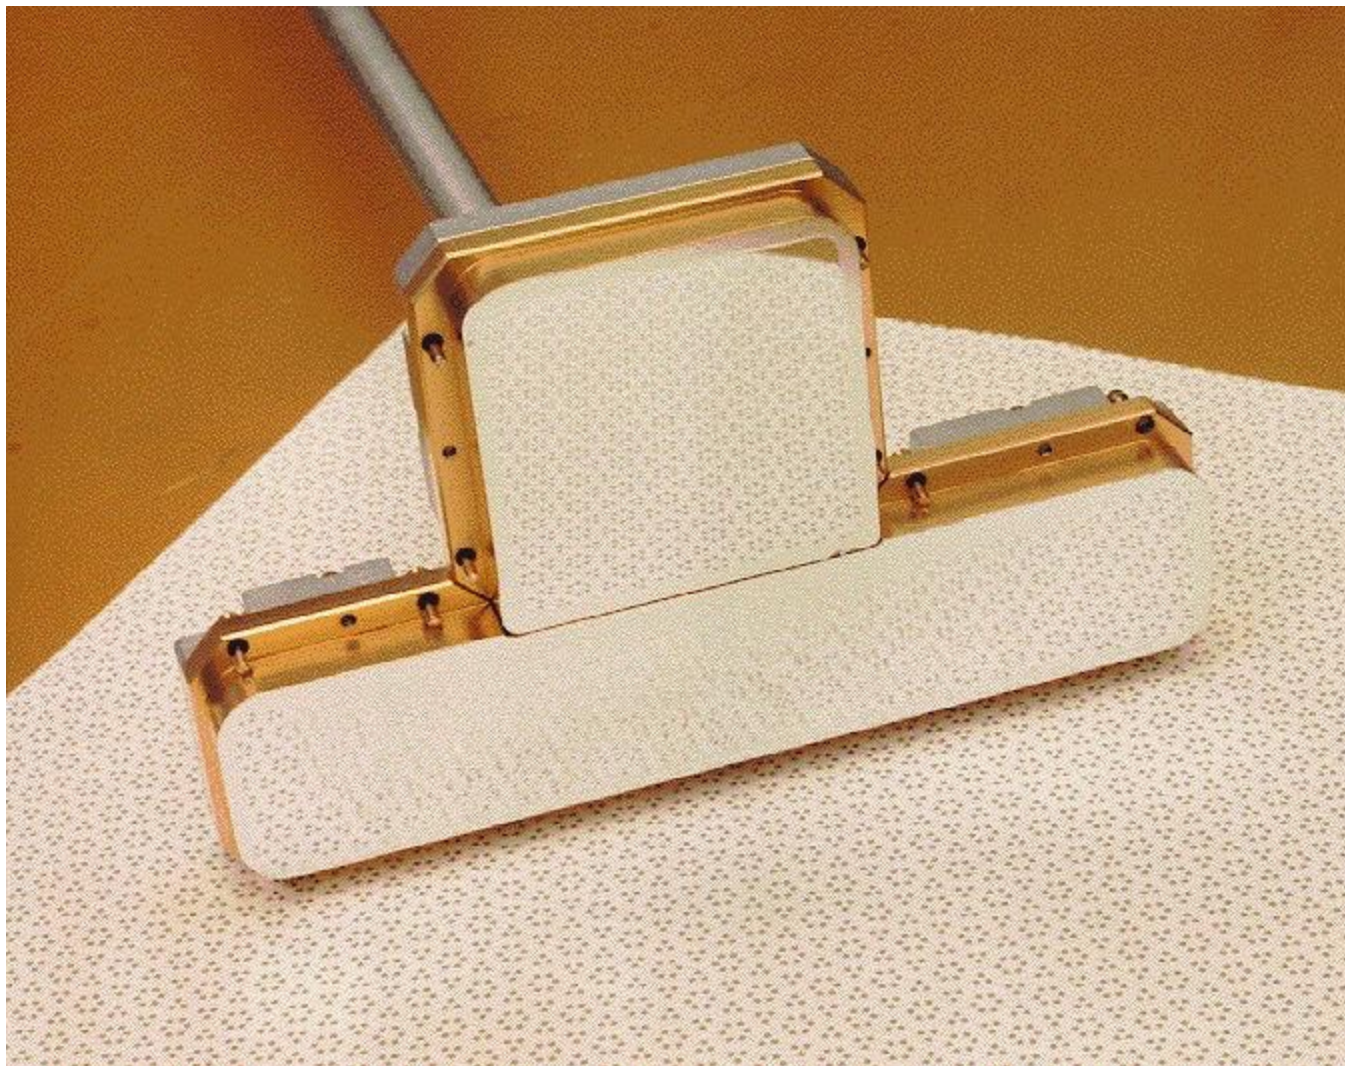
## ACIS Optical Blocking Filter

**ACIS-I OBF**

**Al/Polyimide/Al**

**1200A/2000A/400A**

**ACIS-S OBF**

**1000A/2000A/300A**

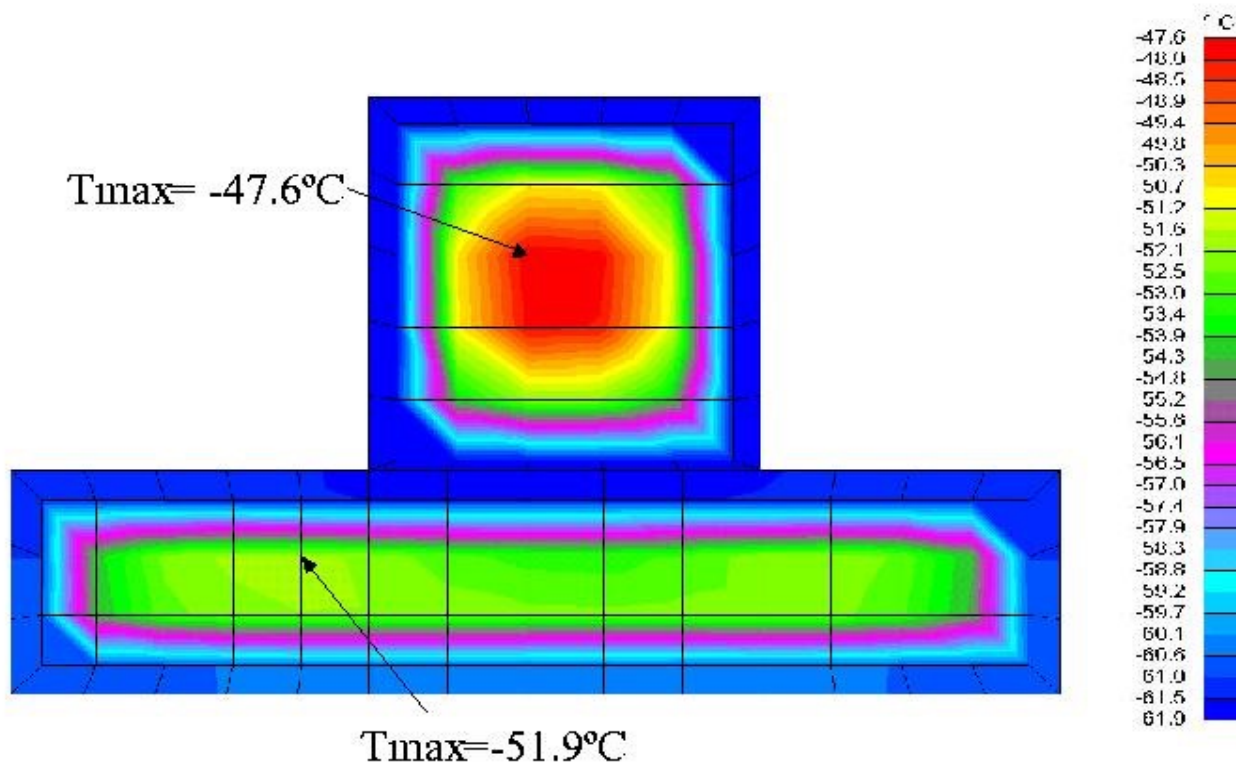
## ACIS Filter Temperatures for Standard Conditions

ACIS Housing -60°C, FP -120°C

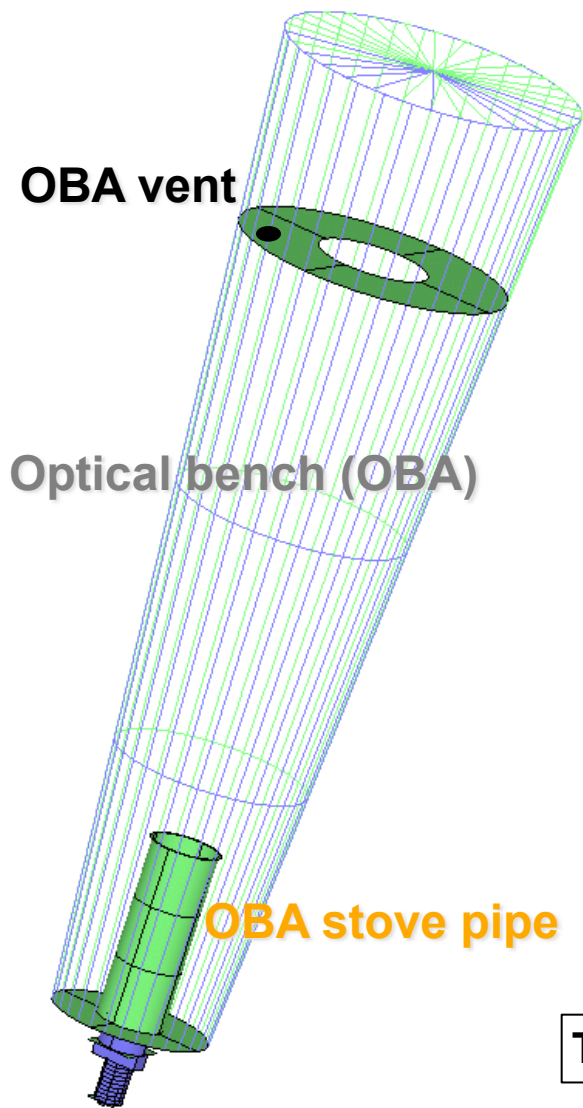
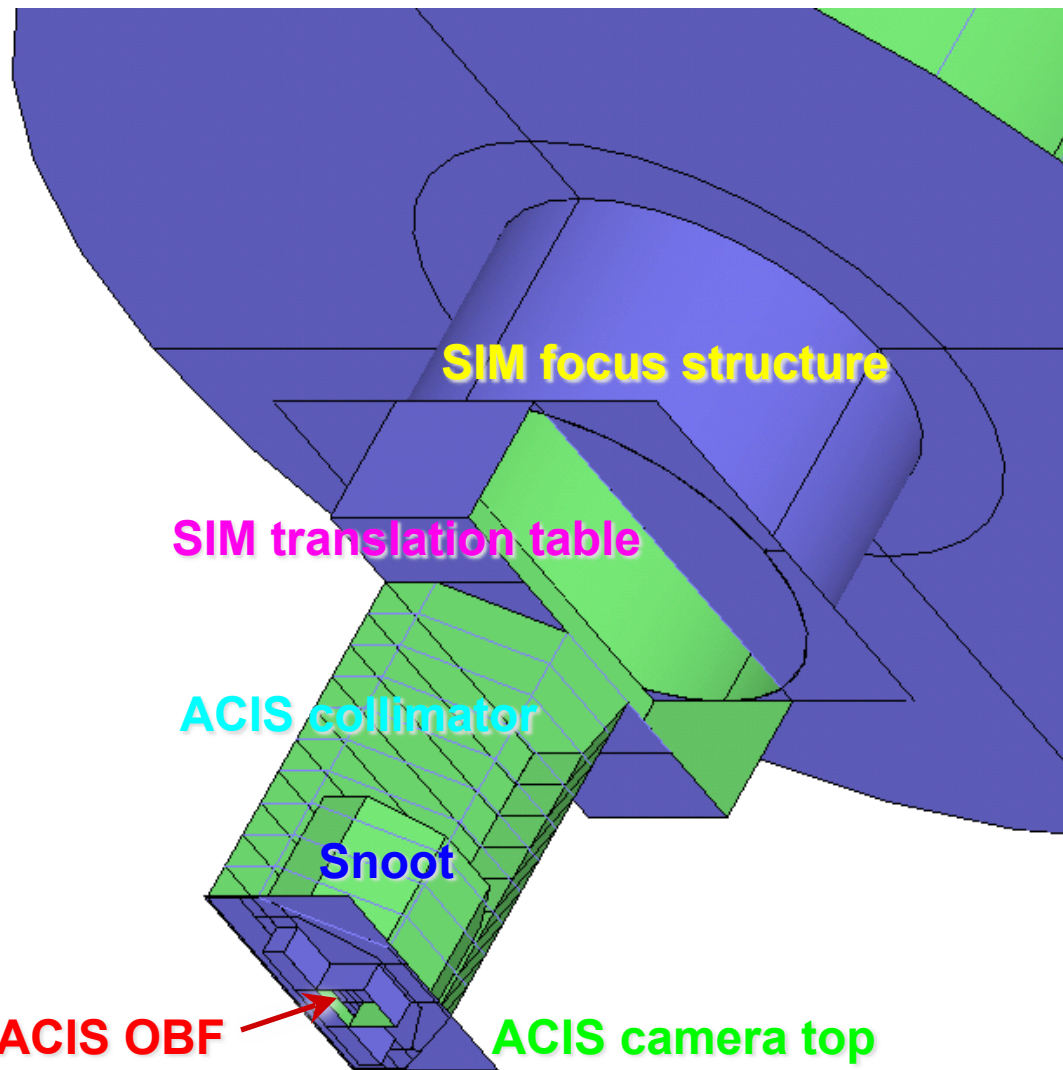
## Geometric model

TRASYS model by NGST/ H. Tran et al.

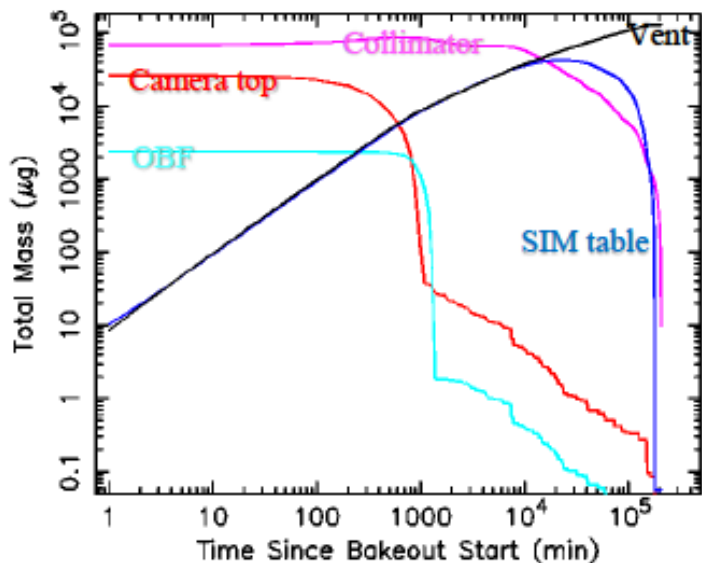
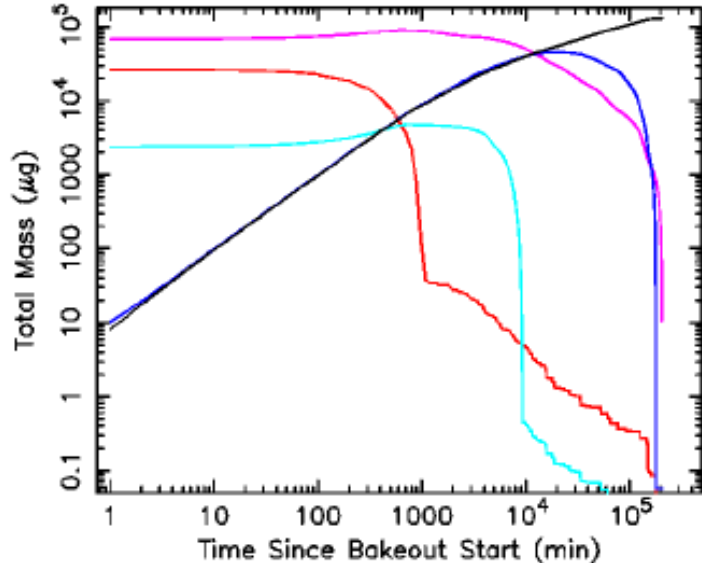
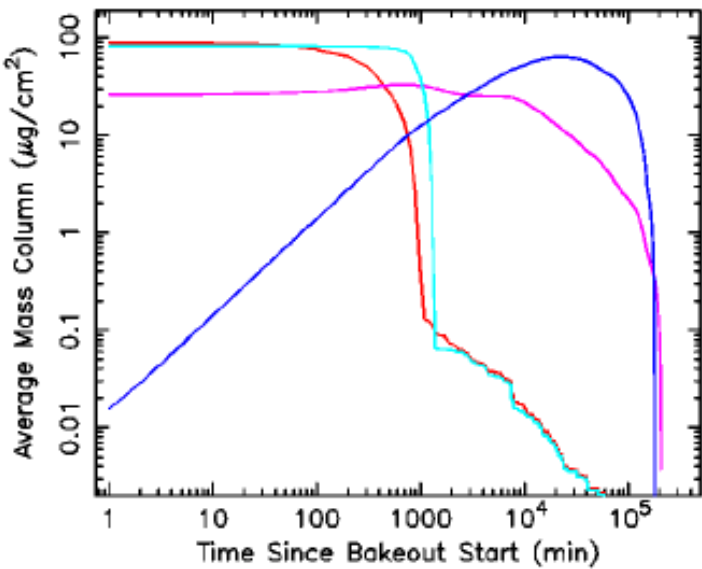
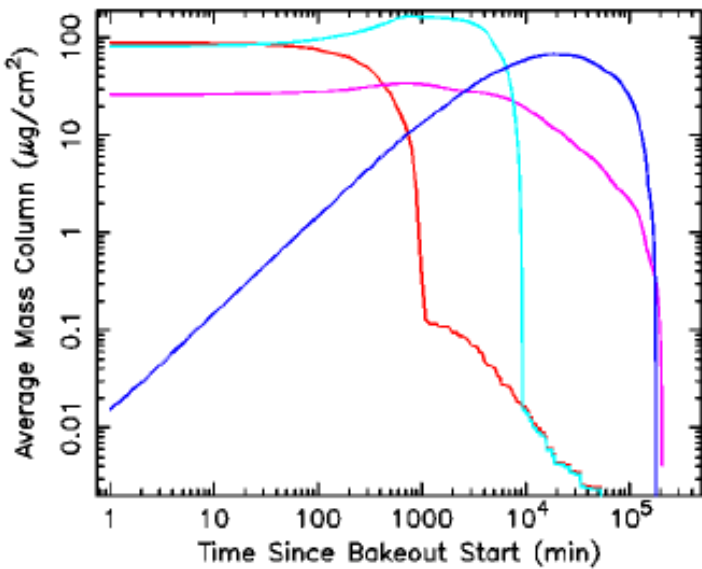
Bakeout

Simulations

Diocetyl Phthalate (DOP)

ACIS OBF  
 Camera top  
 ACIS collimator  
 SIM trans table  
 OBA vent

$2 \times 10^5$  min = 139 days

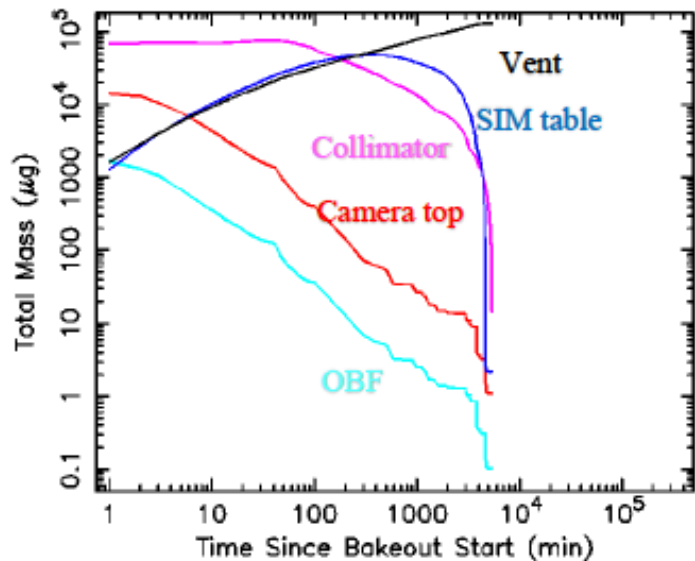
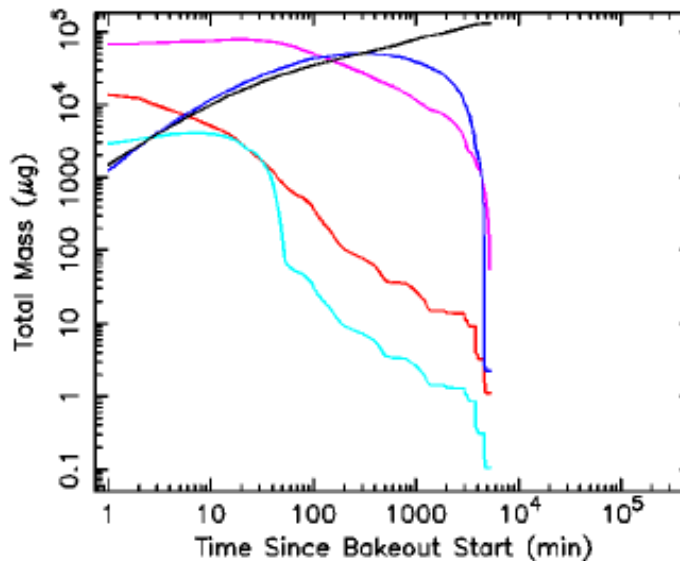
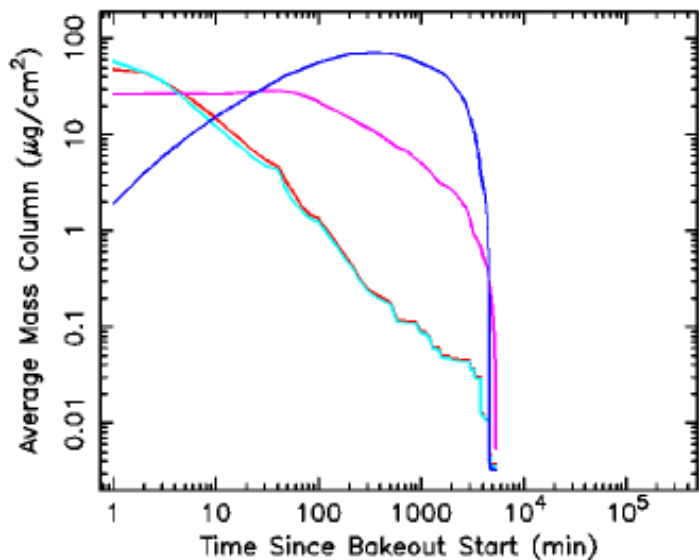
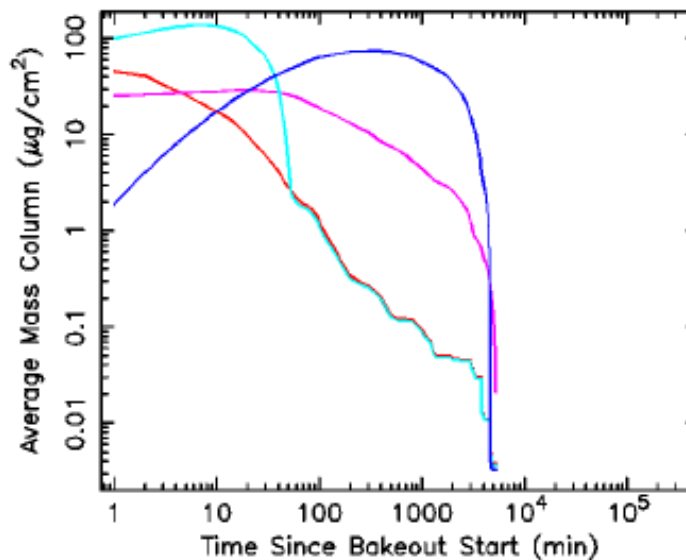
Bakeout  
 Simulations  
 O'Dell &  
 Swartz 2015  
 (MSFC)  
 Octadecane

ACIS OBF  
 Camera top  
 ACIS collimator  
 SIM trans table  
 OBA vent

$6 \times 10^3$  min =  
 4 days
