# UPDATE ON HRC AND LETG ANOMALIES

D. PATNAUDE - 11/8/2021

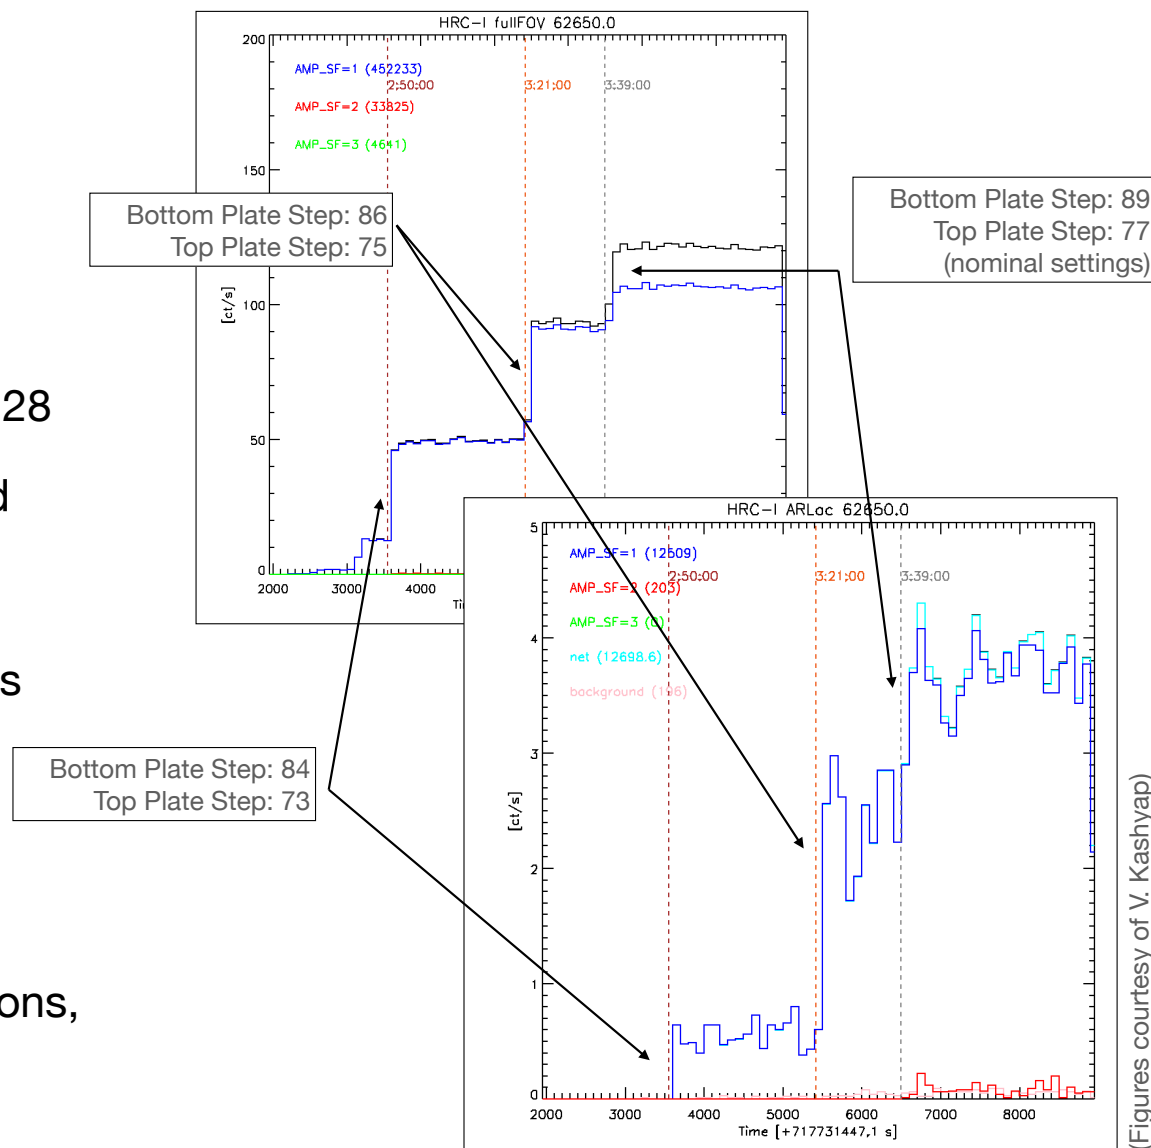
## HRC-I HV ramp up:

- HRC ramp up activity executed on Sep 28
  - voltage was ramped up manually and methodically
- source count rate of  $\sim 4$  c/s and background rate of  $\sim 120$  c/s, Both rates are consistent with expectations
- HRC instrument, SOT, and CAL teams conducted independent analyses of the observation
  - evaluated gain, PHA/SAMP distributions, degap, PSF, and encircled energy

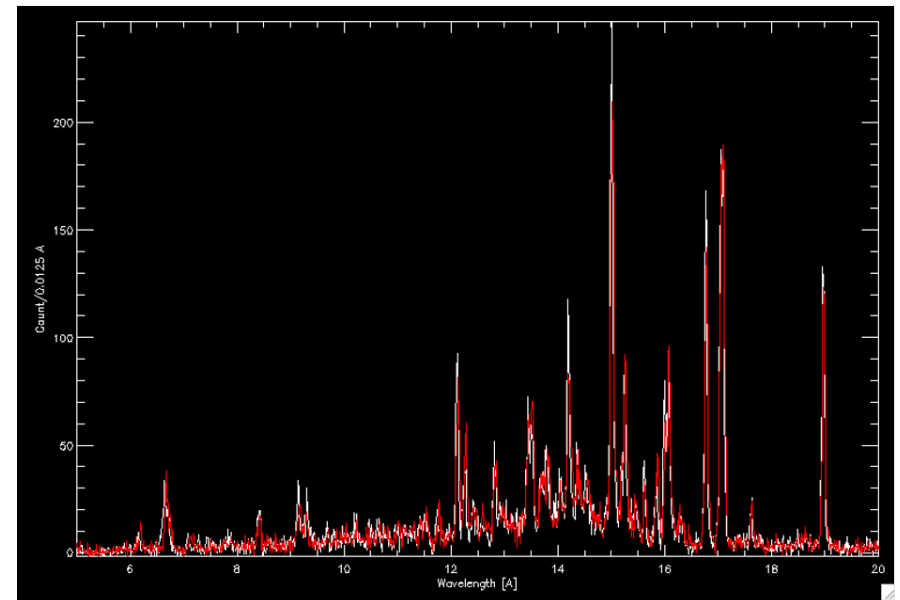
- HRC-S was powered up on the B-side electronics for the first time on October 24, 2020.
- The team performed an observation of AR Lac during an extended comm pass - as in the case of the HRC-I, the data were nominal
- A 2nd checkout observation was performed with the LETG to observe Capella
